OAK TREE FARM PHASE III

(PUD-97-01)

**DRAFT SUPPLEMENTAL
ENVIRONMENTAL IMPACT REPORT
SCH#97092040**

CITY OF PLEASANTON

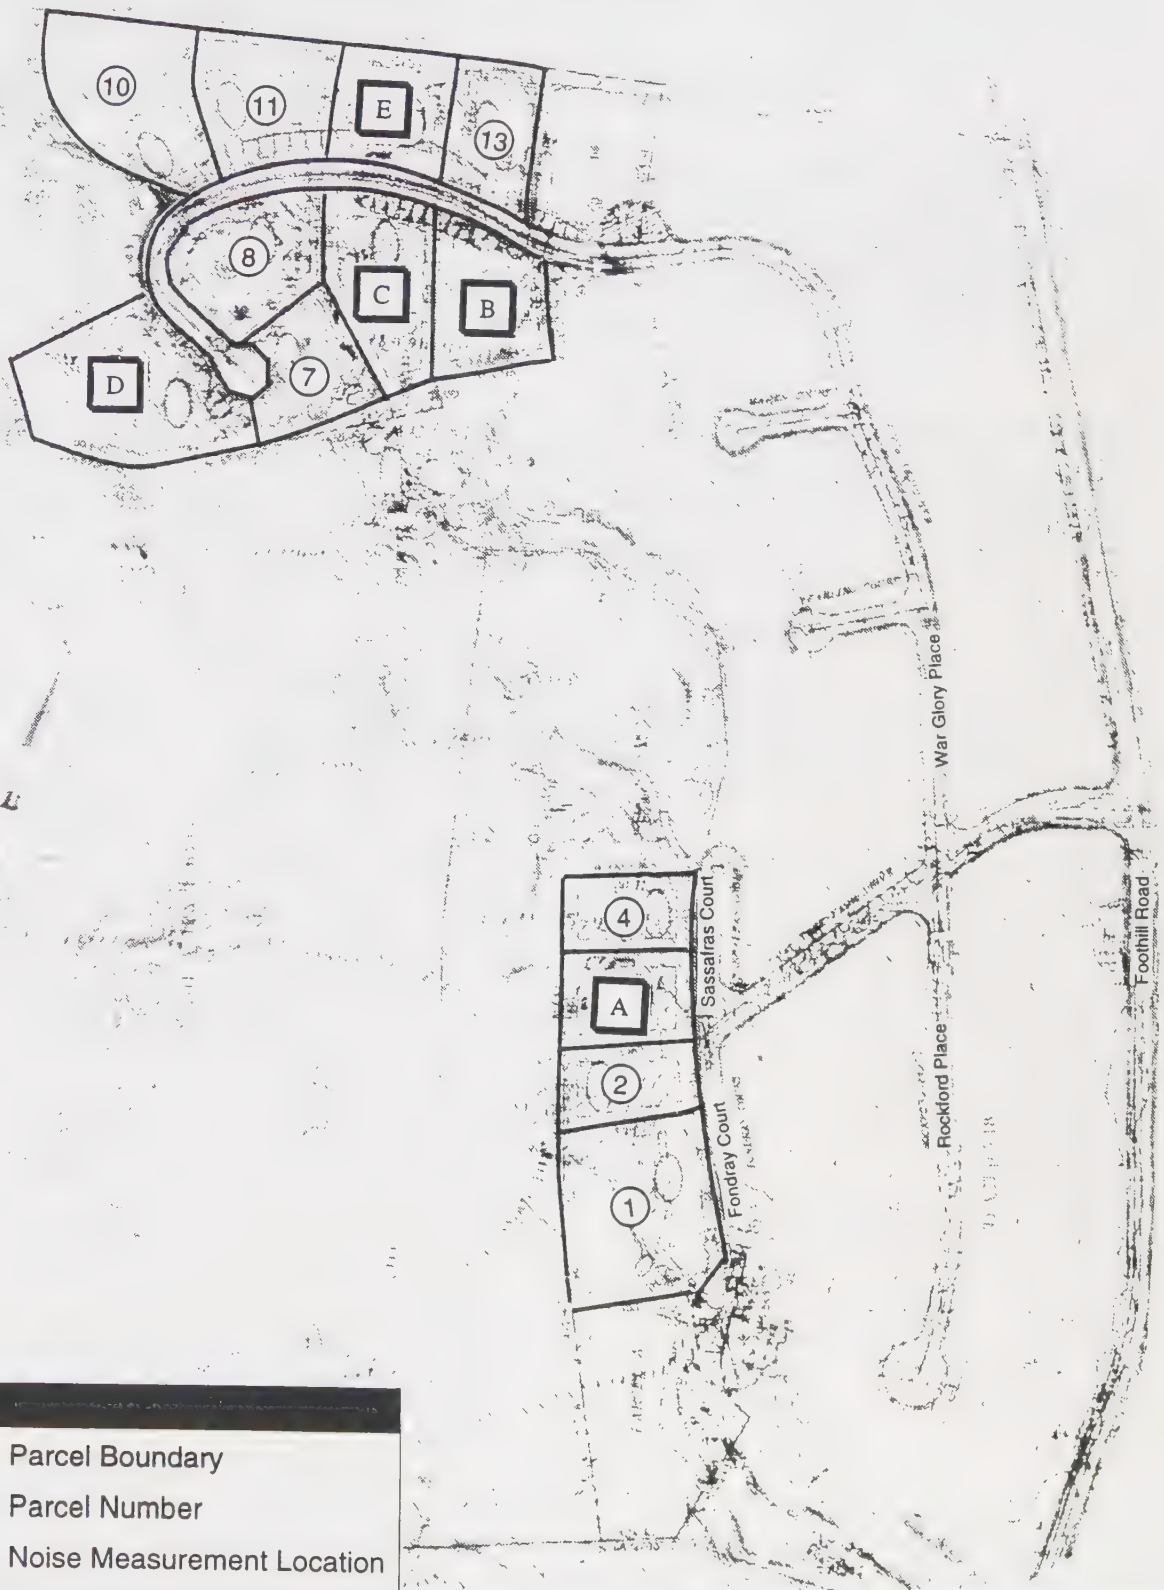
NOISE MEASUREMENT LOCATIONS

To quantify existing noise sources, two 24-hour measurements and three short-term (15 minute) measurements at the site were taken by Charles M. Salter Associates, Inc. in October 1997. Measurement locations were chosen to represent the proposed residential lots. The measurement locations are shown on Map 7-1, and the results of the measurements are shown in Table 7-1. As Table 7-1 indicates, the DNL varies from 63 to 65 dB at lots with line-of-sight to I-680. The DNL is less at Lot 12 because there is significant acoustical shielding from the existing terrain. **Since the DNL for Lots 3, 5, 6, and 9 ranges from 63 dB to 65 dB, and the City goal for backyards of single-family homes is generally 60 dB, this is considered a significant adverse impact.**

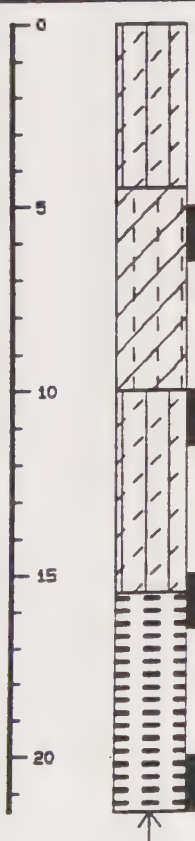
ML	Dark brown Pebbly Clayey SILT					
5		CL	Red brown Pebbly Silty CLAY, dense, stiff, slightly moist		14-1	26		
10		ML	Mottled tan/red brown Gravelly Clayey SILT and Sandy Clayey GRAVEL		14-2	35	122	9
15			Mottled tan/light grey fine grained SANDSTONE w/small whitish fragments (shell fragments?), hard, massive (QT1)		14-3	67		
20			Mottled tan/red brown coarse granular SANDSTONE w/some small pebbles, looser than above		14-4	38		
			Boring terminated at 21.5 ft No groundwater encountered

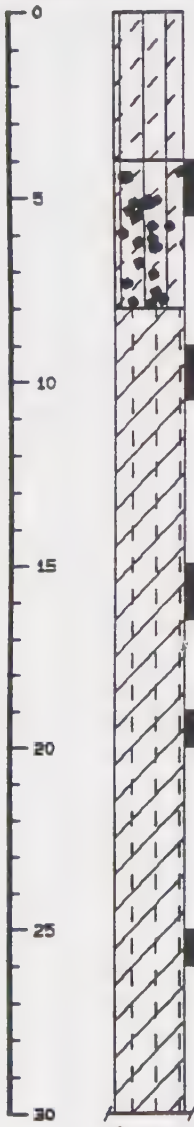
ML	Light brown Clayey Pebbly SILT					
5		ML	Mottled light tan to light red brown Clayey Gravelly SILT		15-1	35	113	15
10		CL	Mottled red brown/grey Pebbly Silty CLAY		15-2	32	115	17
15			As above with Slickensided low-angle planar shear (SLIDE DEBRIS)		15-3	50		
20			As above w/Sandstone cobble (OLDER SLIDE DEBRIS)		15-4	77		
25			As above		15-5	59	115	11
30

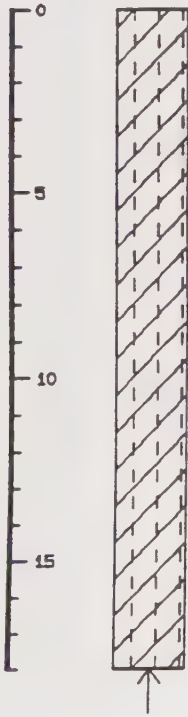
ML/ CL	Medium brown Silty CLAY/ Clayey SILT w/minus 1/8 clast Gravel. dry. loose to firm					
5			Stiffening	LL=34 PI=15	35-1	31	105	8
10			Grading to CLAY w/slight moisture		35-2	36	113	13
15			As above. rounded 1/2" clasts Gravel					
			Boring terminated at 18 ft No groundwater encountered

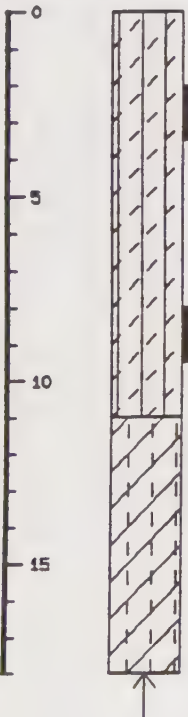
ML/CL	Medium brown Clayey SILT, dry to moist, loose to firm w/fine Sands		37-1	15	115	8
5								
10			As above		37-2	22	99	15
15		CL	Light brown Silty CLAY, moist, firm to stiff					
			Boring terminated at 18 ft No groundwater encountered

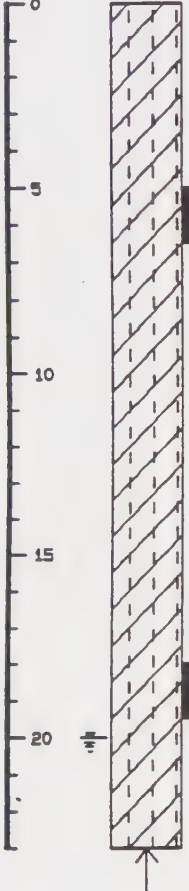
CL	Dark brown Silty CLAY, moist to wet, firm					
5				C=580 psf 0=25	38-1	26	101	25
10			Light brown Sandy Silty CLAY, dry to moist, firm to stiff					
15			Medium to dark brown Silty CLAY, mottled w/gray, moist to wet, firm to stiff					
20			Water @ 20' at time of drilling		38-2	12	103	21
			Boring terminated at 23 ft Water at 20 ft

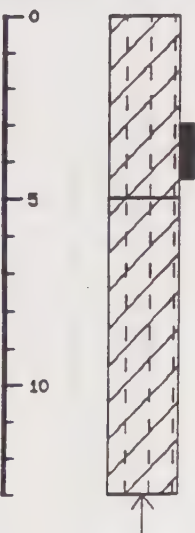
ML/	Light brown Silty CLAY/Clayey					
		CL	SILT, dry, loose	LL=37 PI=16	39-1	28	109	7
5		CL	Medium brown Silty CLAY, dry to moist, firm to stiff w/ 1/4" minus rounded Gravel					
10			Boring terminated at 13 ft No groundwater encountered

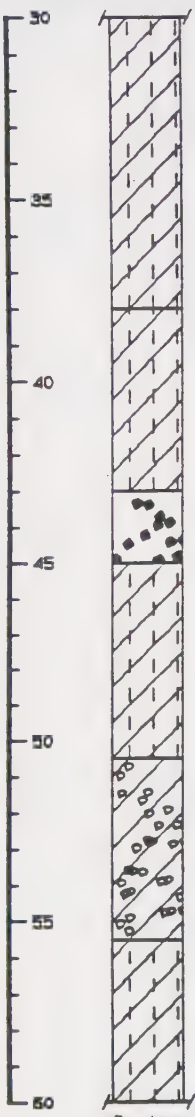
35								
40			Very dark brown pebbly Silty CLAY					
45			GRAVEL					
50			Very dark brown pebbly Silty CLAY					
55			Dark brown Gravelly CLAY and Clayey GRAVEL					
60			Dark grey brown Silty CLAY					
	Boring Continues

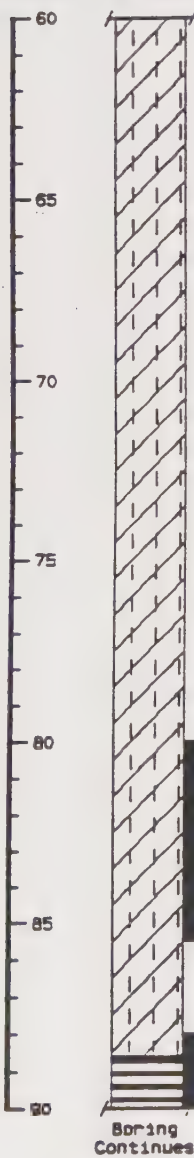
Dark grey pebbly Silty CLAY (slide debris)					
65								
70								
75								
80			Very dark grey pebbly CLAY (slide debris) angular clasts Claystone in stiff Clay matrix	Mostly plug	53-1 53-2	25 72		
85			As above, brecciated texture	weekend satu- ration	53-3 53-4	14 53		
			As above, but light green serpentinous material in shoe	Incom. sample Drilled	53-5 53-6	53 50/1"		
			As above, with serpentine pod in shoe	85.5 to 88'				
			Hard cemented GRAVEL with finely granular serpentine	Slide Plane	53-7	45		
			Hard drilling with soft streaks	@88.7'	53-8	51		
			Olive green/khaki w/blue green mottling Silty CLAYSTONE w/ blue grey Sandstone clasts

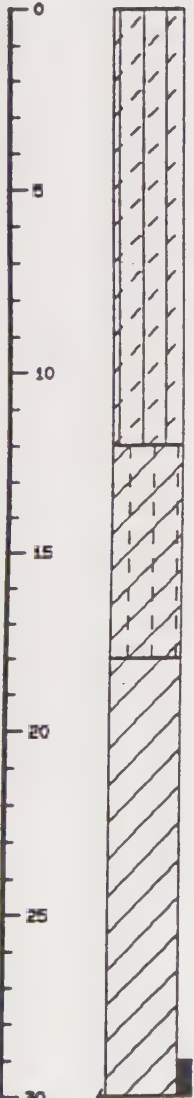
Medium brown pebbly Clayey SILT, dry grading to slightly moist					
5			With reddish brown zones					
10								
15			Medium grey brown pebbly to Gravelly Silty CLAY and Clayey SILT with streaks Gravel					
20			Light brown pebbly CLAY, grading to grey brown					
25								
30			Khaki and olive drab with blue grey mottling pebbly Silty CLAY, dense, stiff, moist		54-1	36

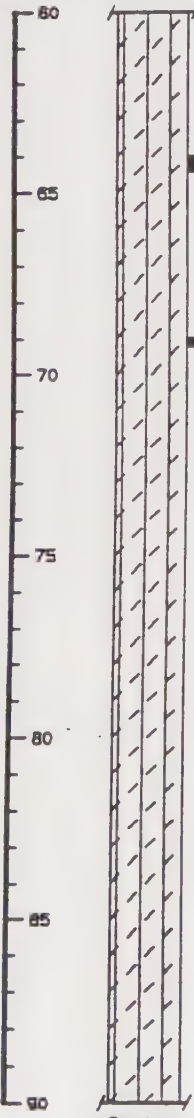
65			Blue grey pebbly SANDSTONE		54-2	50/5'		
70			As above to Gravelly SANDSTONE		54-3	50/3'		
75								
80								
85								
90

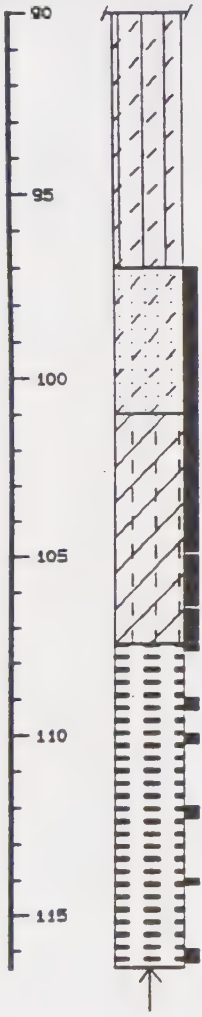
95			Softer at 94'.					
			Blue grey Clayey SAND (or soft Sandstone), scattered caliche blebs & nodules H2S odor		54-4	42		
					54-5	50/8"		
					54-6	41		
100					54-7	50		
					54-8	48		
			Grades through Clayey SILT to Silty CLAY, dark blue green or greenish blue grey		54-9	44		
			Dark blue green Silty CLAY with pods or lenses of fine Sand		54-10	54		
105			As above with polished partings		54-11	57		
					54-12	50		
			Light blue grey pebbly SANDSTONE in shoe, very hard, calcite-cemented	Drilled 108.2 - 109.0'	54-13	50/2"		
110			As above, but more Gravelly	Drilled 109.4 - 110.0'	54-14	50/4"		
					54-15	50/3"		
				2" sampler	54-16	50/4"		
					54-17	50/2"		
115					54-18	50/4"		
			Boring terminated at 116.5' No groundwater encountered.

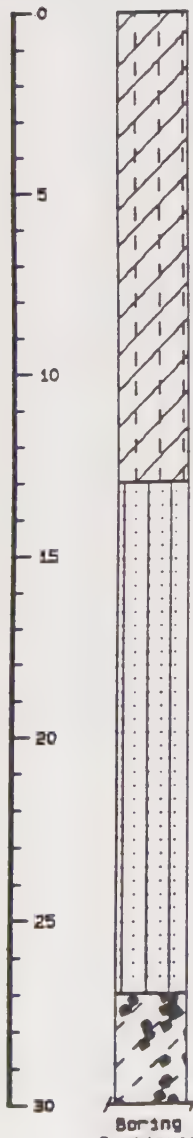
Medium to light brown pebbly Silty CLAY and Clayey SILT					
5								
10								
15			Light tan Gravelly SILT and SAND					
20								
25								
30			Brown Clayey GRAVEL					
Boring Continues

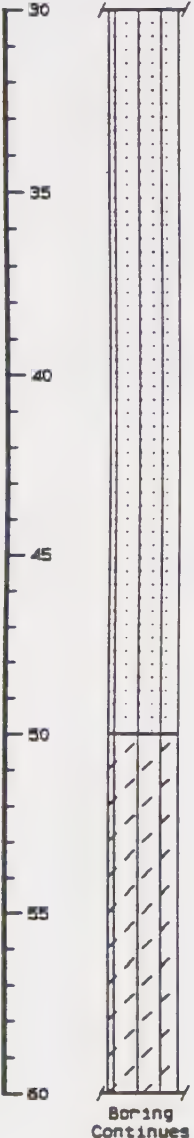
Brown Clayey SAND and SILT					
35								
40								
45			More moist					
50

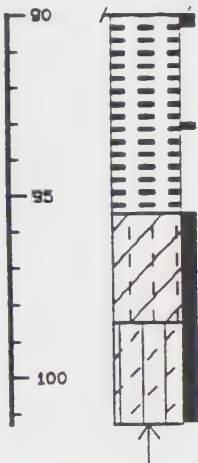
As above, but coarser with some small pebbles	Drilled to 93'	55-10	50/4'			
		As above with some Gravel	Drilled to 95.5'	55-11	50/2'			
95		Blue grey Silty CLAY with specks and blocks of caliche		55-12	37			
				55-13	47/9'			
		Blue grey Clayey SILT with scattered pebbles		55-14	47/10'			
100		As above, but no pebbles		55-15	55			
				55-16	49/10'			
			Boring terminated at 101.3' No groundwater encountered.

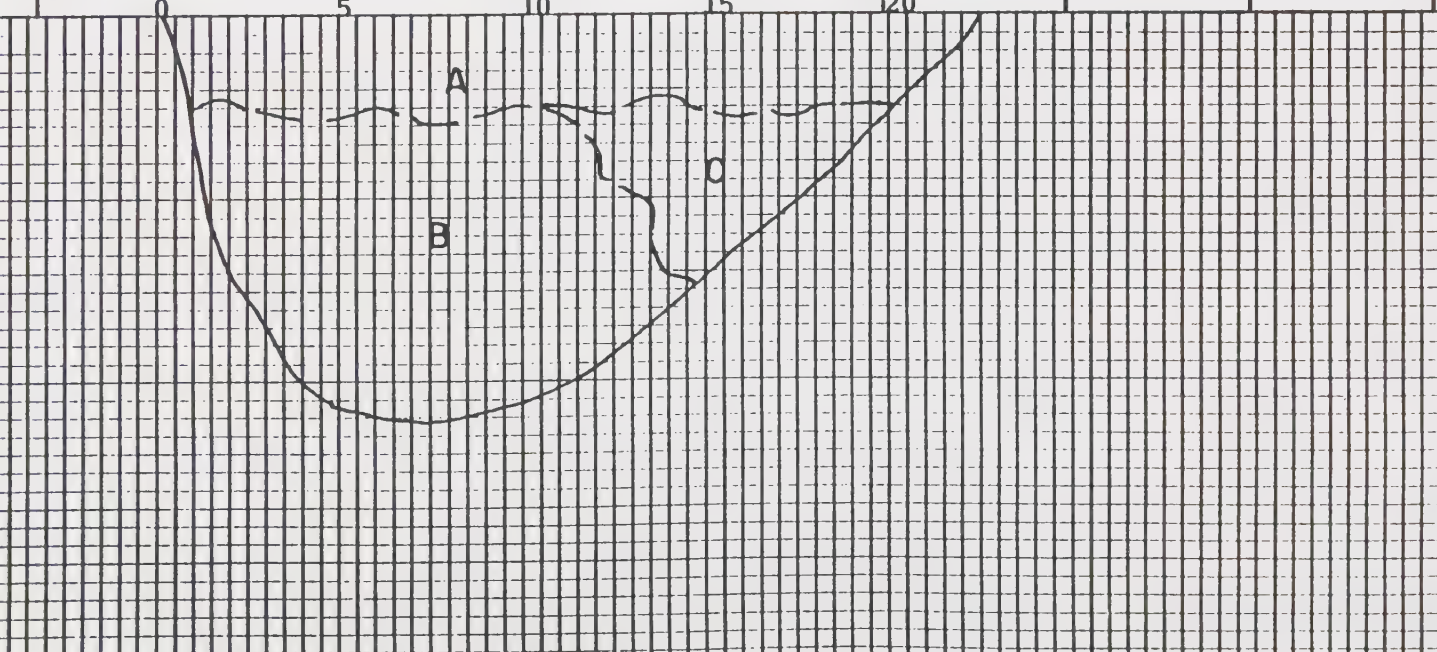
ELEV.		LOGGED BY		RR		DATE LOGGED 12/21/87	
DEPTH	MATERIALS DESCRIPTION TYPE, COLOR, MOISTURE, CONSOLIDATION, ETC.	ATTITUDES			COMMENTS		
		BEDDING	JOINTS	FAULT or SHEAR			
0 - 2.5 (A)	Dark brown pebbly Clayey SILT; soft, moist, porous (topsoil)	none	none	none			
2.5-11.0 (B)	Mottled medium brown Gravelly, Clayey SILT; hard, dense, very hard digging	none	none	none			
2.5-7.0 (C)	Grey pebbly CLAY; dense, stiff	none	none	none			
<div>TEST PIT LOG No. 13</div> <div>Figure No.</div> <div>TERRESEARCH INC.</div>

<div>SCALE</div> <div>HORIZ. 1"=5'</div> <div>VERT. 1"=5'</div> <div>PIT ORIENTATION</div> <div>N48E</div> <div>NATURAL SLOPE</div> <div>ANGLE 90°</div> <div>T.D. 11'</div>
